# TECHNICAL NOTE

## FabGuard® HYT *In Situ* Particle Monitor and Tool Data Sensor

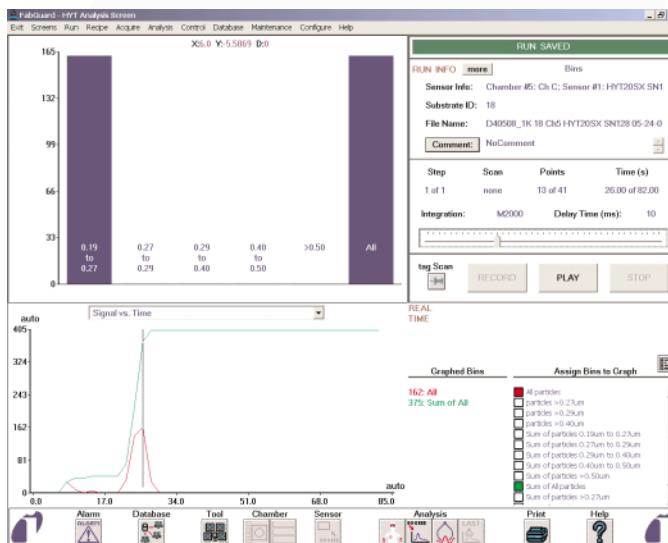
Figure 1. HYT particle counts for a normal wafer.

Figure 1 and Figure 2 show that the HYT sensor can easily distinguish between low and high particle counts in an etch preclean chamber. Figure 13 shows the particle counts for a normal wafer. The lower plot shows the time series data from two Bins: the number of particles of any size for each time interval (red) and the cumulative sum from wafer start of the number of particles of any size (green). The maximum number of particles for any one-time interval was 162. The total number of particles accumulated over the entire process was 402, which was typical for this process. The upper left plot indicates that essentially all of the particles were small, 0.19 to 0.27 microns, which was typical for this process.

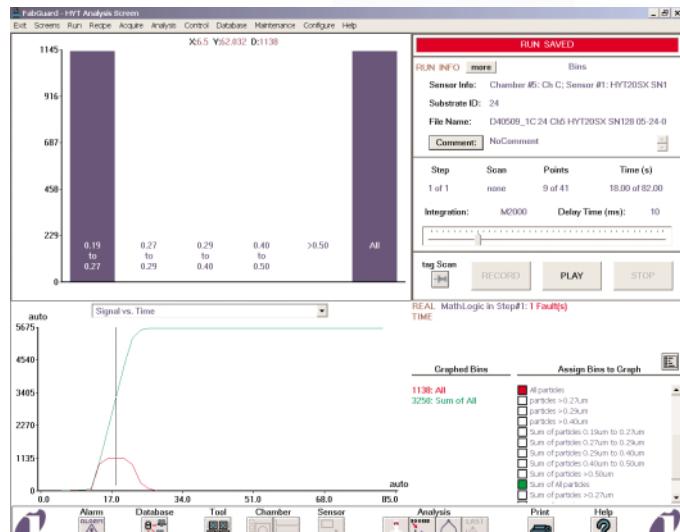
Figure 2. HYT particle counts for a wafer with abnormally high particle counts.

Figure 2 shows the particle counts for a wafer that had particle problems. The maximum number of particles for any one-time interval was 1138, which is 7 times higher than the normal wafer. The total number of particles accumulated over the entire process was 5644, which is 14 times higher than the normal wafer. These particle counts were high enough that FabGuard generated an alarm and sent an alarm message to the processing tool.

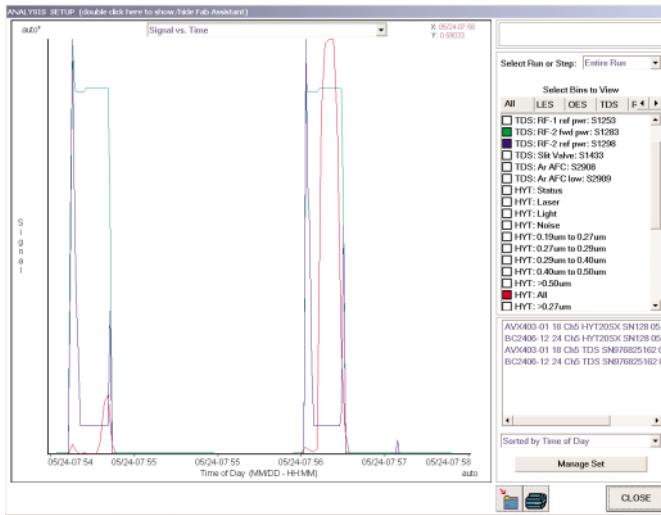
Figure 3 shows how TDS and HYT data combined to help pinpoint the particle problem. TDS collected the following variables: Pressure (capacitance manometer), Pressure (ion gauge), RF-1 Forward Power, RF-1 Reflected Power, RF-2 Forward Power, RF-2 Reflected Power, Chamber Slit Valve Open/Closed, Argon Flow (standard AFC), and Argon Flow (low flow AFC). RF power, especially RF-2, proved to be the most strongly correlated with the high particle counts. Pressure and gas flow were not significantly correlated with particle counts. The figure shows the time series data from three Bins for both the normal and abnormal wafers: the number of particles of any size for each time interval (red), the RF-2 Forward Power (green), and the RF-2 Reflected Power (blue). The vertical axis uses different scaling for each Bin.

Figure 3. Correlation between HYT particle counts and RF-2 forward and reflected power.

The normal wafer has a small particle peak when RF-2 turns on and a larger peak when RF-2 turns off. Both of these particle peaks turn out to be typical for this process, because some particles are produced when the RF-2 reflected power is high. The abnormal wafer is different because it has a much larger and broader particle peak during the middle of the process.

Both processes used the same recipe, so the different particle counts were not caused by differences in the recipes. Notice that the large particle peak in the abnormal wafer starts about 8 seconds after RF-2 turns on. This time delay indicates that the particles are produced only after the plasma has been on for several seconds. This implies a few possible sources of the particles: (1) they could have formed in the plasma, (2) they could have been generated by the interaction of the plasma with the chamber walls, or (3) they could have been generated by the interaction of the plasma with the wafer surface. The first two possibilities were ruled out because the normal and abnormal wafers were processed one right after the other. This left only the interaction of the plasma with the wafer. It turned out that the important difference was that the two wafers came from different lots. In fact, every wafer in one of these two lots exhibited about 10 times higher particle counts than normal. In other words, the incoming wafers were causing the particle problem. Using the Lot IDs maintained by FabGuard, the cause of this problem was tracked to one specific upstream tool. When this upstream tool was repaired, the particle problem went away.
