# Appliance®

## Sensing a Problem

**A**dvancements in leak detection technology are allowing Whirlpool Corporation to meet efficiency goals and produce more reliable refrigerators in plants around the world.

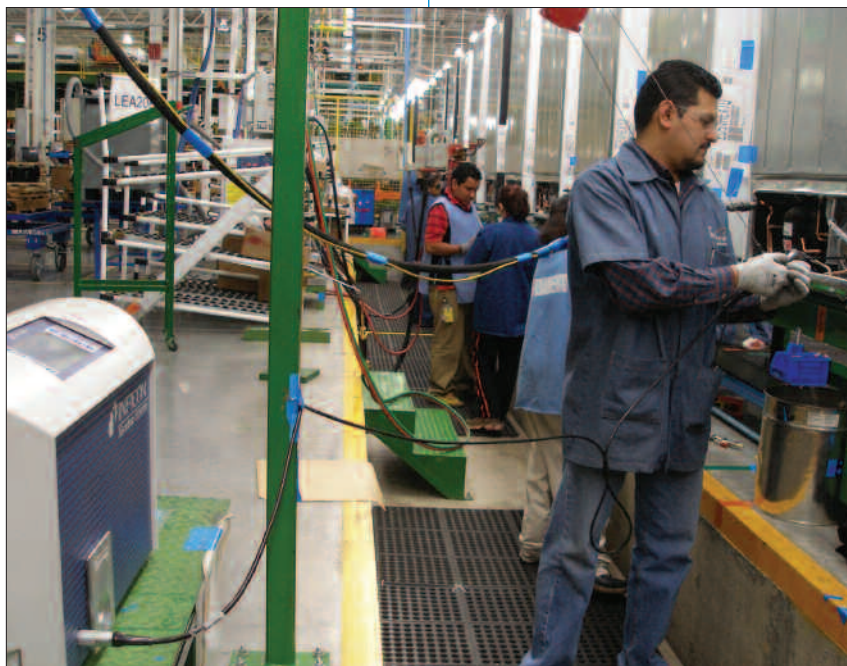
*Whirlpool Corporation in Joinville, Brazil, recently purchased new leak detection equipment for the production of one-door refrigerator models, top-mount models and horizontal and upright freezers.*

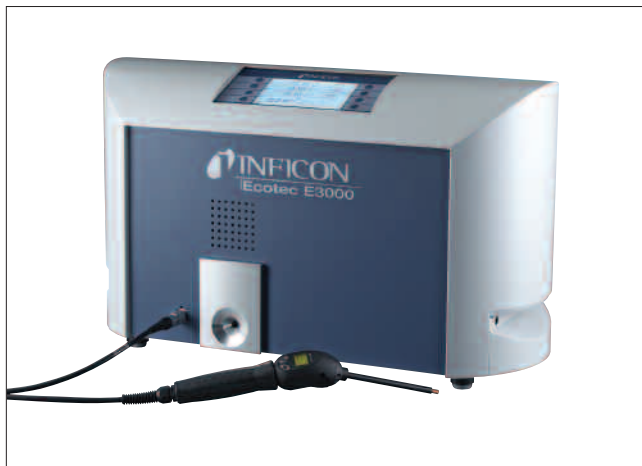
*To cater to Whirlpool's needs, Inficon developed the Ecotec E3000 with two major improvements—heightened sensitivity and faster flow. "Technology was of utmost importance in meeting our goal, as the technological improvements of the new products addressed our demands successfully," says Nelson Possamai of Whirlpool. "The new Inficon detectors were most helpful in eliminating false alarms in the leak detection system, in improving the speed of assembly lines and in decreasing the instability of labor."*

Using new digital signal processing in the software, the improved sensor can measure different signals and evaluate them against each other to differentiate the refrigerant signal from the foam signal. "This is only possible because the sensor is working in real-time," Seitz says. "You cannot sniff the refrigerator and then wait until the unit has calculated the results. So the real achievement here is that the leak detector does all of these calculations and evaluations with essentially no lag time (about 10 milliseconds), and then shows the operator only real leaks from the refrigerant and not the foaming agent."

In addition to eliminating false alarms, the sensor also addressed some of the challenges Whirlpool was having in detecting actual refrigerant leaks. "Inficon was able to produce a leak detection product line with a new vacuum design with higher flow though the sniffer line in correspondence with faster sensors," Possamai explains. "This allowed us to identify leaks more effi-

In addition, because the new detector sucks in air from a greater volume, it allows operators to detect leaks from greater distances. With the old system, if the operator was not close enough to the leak, then the system did not pick up the leak. "The increased flow makes the process less prone to error, or as we say, more tolerant to operator variation," Seitz explains.

Seitz says that when you increase the flow, the device is not only sucking in more gas from the leak, it is also sucking in gas from the surroundings, which can decrease sensitivity. "So you can only do this if at the same time you improve the absolute sensitivity of the sensor," she explains.

Other improvements included a redesign of the display, which now resembles an ATM machine display with eight buttons on the side. "There are a lot of messages that you can send to the operator, and he just pushes a button and is able to get the information he needs," Seitz says.

The sniffer also has its own display, a feature not offered on previous models. Because the operator has to closely watch the probe to ensure the right joint is being sniffed, Seitz says it only makes sense that a display would be located directly in the operator's view. "Customers say they really like this feature because the operator can concentrate on the sniffing process and not even bother (worry) about the main unit in the background," she says.
