**NAVAIR News Release  
FRCSE Public Affairs**

**FRCSE locates potential fuel leaks with earth-friendly technology**

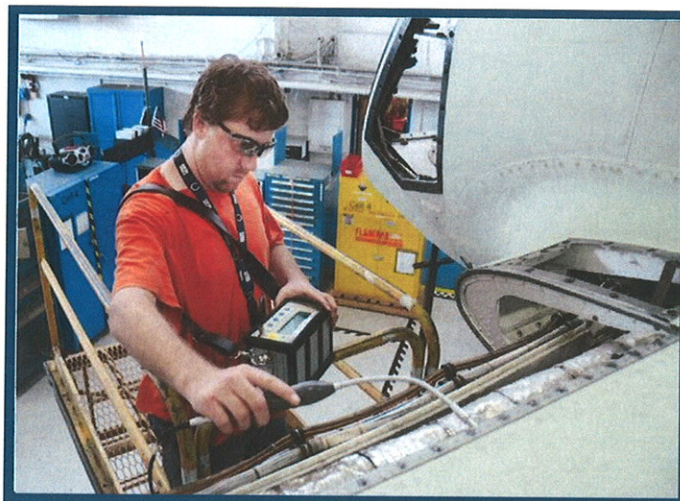
121001-N-UL949-003 JACKSONVILLE, Fla. (Oct. 1, 2012) Sheet Metal Mechanic Bryan Swafford inspects a P-3 Orion wing tank for potential fuel leaks using hydrogen leak detection technology at Fleet Readiness Center Southeast (FRCSE). During Fiscal Year 2012, FRCSE established the new leak detection capability for the P-3 aircraft that has reduced the turnaround time of aircraft wet check by 15 percent and provided a cost avoidance of nearly \$20,000 per aircraft. Chemist Kellie Carney with Materials Engineering and Engineer Dan Marlowe, along with the P-3 Fleet Support Team implemented the process that employs 5 percent hydrogen and 95 percent nitrogen trace gas. This technology restores the fuel leak detection capability lost with the banning of Chloro-Fluoro Carbon (CFC) 113 in 1996. (U.S. Navy photo/Released)

Hydrogen leak detection technology uses a 95 percent nitrogen to 5 percent hydrogen mix trace gas that is non-flammable and inherently safe. The hydrogen trace gas is injected into the empty (sealed) fuel tank, and the external tank surface is probed with the portable detector to find and locate leaks. When detected, the unit provides a visual LED light and audible alarm.

The hydrogen leak detector uses a “sniffer” probe that has the capability to detect extremely small leaks. The P-3 Fleet Support Team (FST) established a threshold to identify the smallest opening with the potential for leaking fuel. To validate, the team performed several tests on multiple P-3 aircraft and verified that no fuel leaks were observed during initial wet check/fueling operations.
